SPECIAL PROJECT REPORT

SPR X/2004

PERFORMANCE ASSESSMENT OF GREENING TECHNIQUES ON SLOPES

B.L.S. Lui & Y.K. Shiu

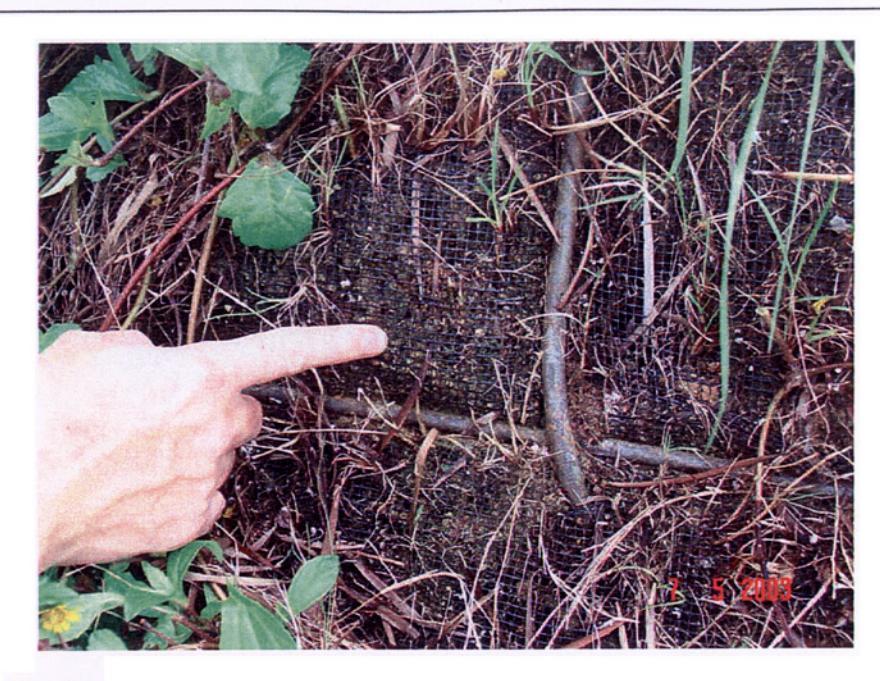
Plate 7a

Horizontal bracing in the form of steel bars on system surface
11NW-D/C130
Chung Hau Street, Homantin
7 May 2003

Two slopes no 11NW-D/C130 and 11SW-D/C111 were inspected for engineering assessment of this product. On slope C130, mild steel bars of 10 mm diameter are fixed on to the surface of the soil mix horizontally across the slope at a vertical spacing of about 1.5 m (Plate 7a). These horizontal bars act as bracing to provide additional support to the soil mix. Minor bulges of the mulch/soil mix were noted and they were confined by the horizontal steel bars. There were no apparent signs of surface cracking or detachment of soil mix. A layer of long-term non-degradable erosion control mat was provided on the surface of the two slopes. No sign of weakening was noted on these mats at the time of inspection and they were securely anchored on the slopes with tension. Edges of the system were noted to be well-protected by mats pinned on the slope.

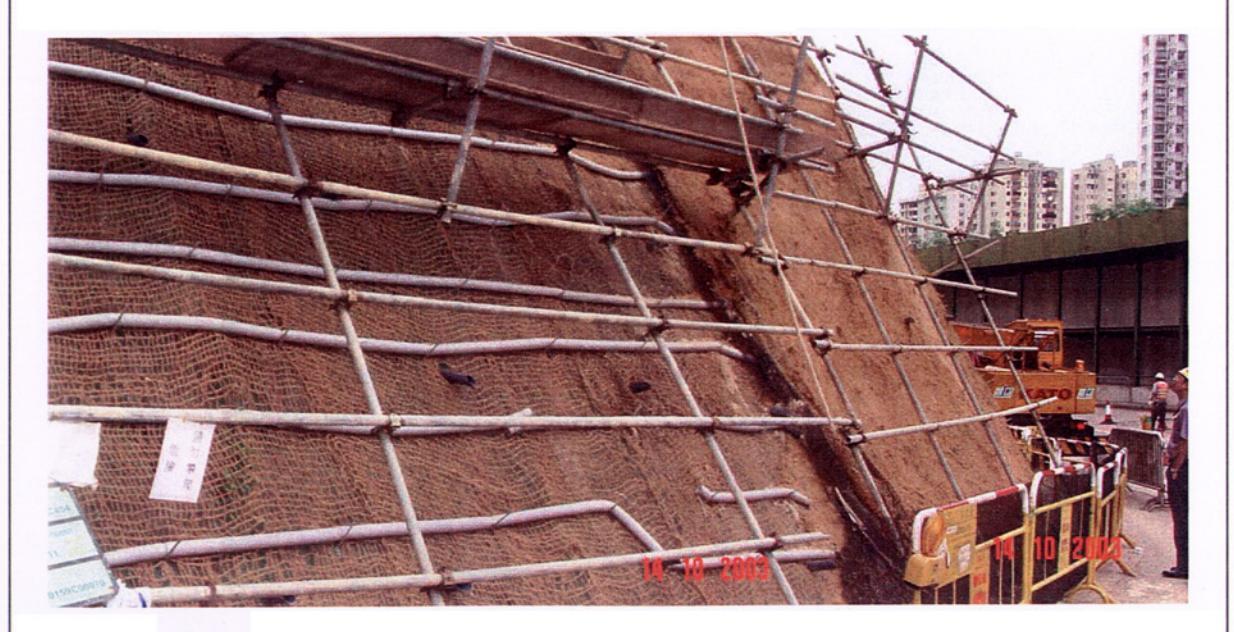
Plate 7b

Horizontal support within the soil mix in the form of PVC pipes 11NW-D/C131 Location: Chung Hau Street, Homantin Date of Inspection: 14 October 2003

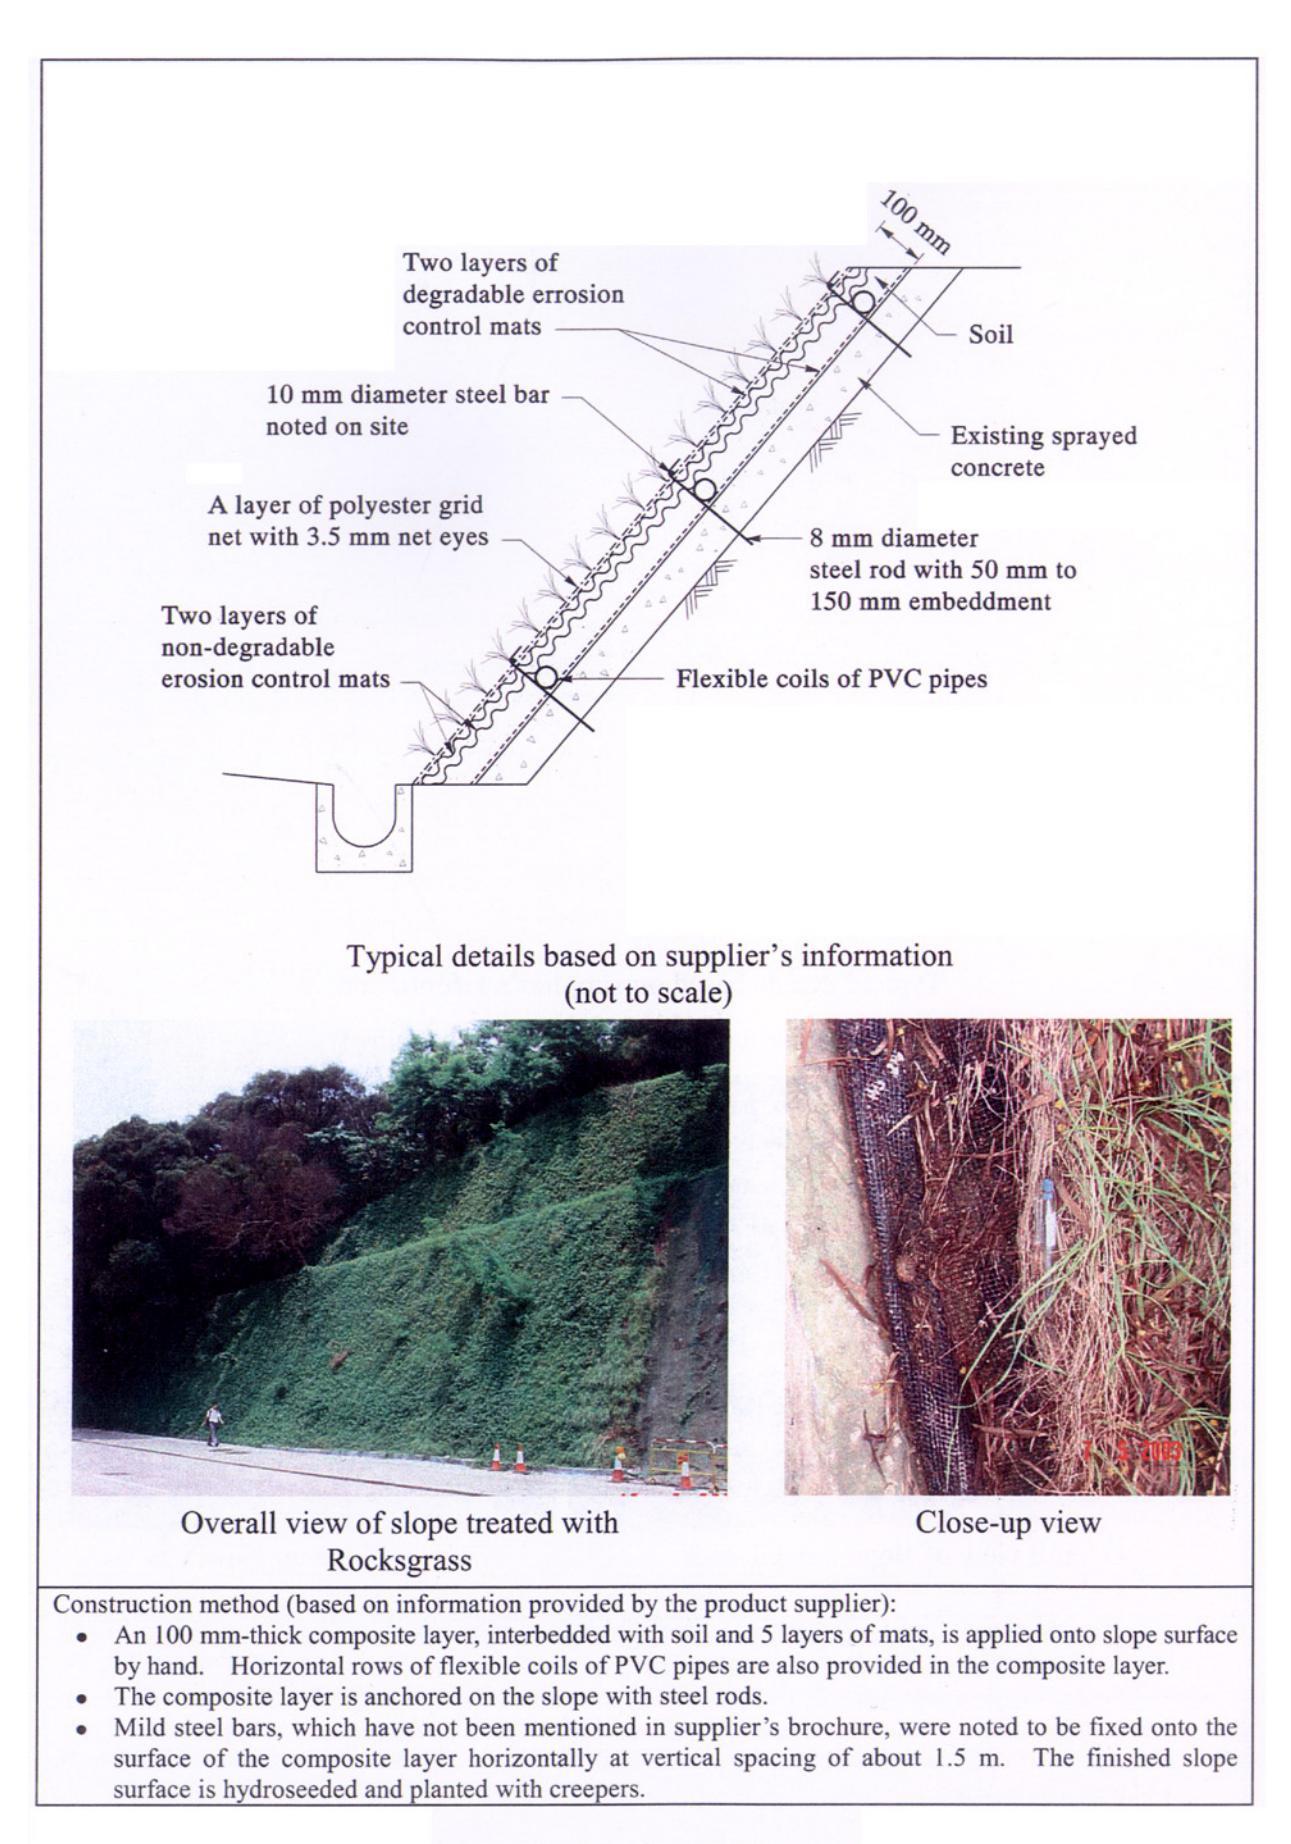
Figure 5 - Details of Rocksgrass

The mulch/soil mix in this system is alternately interbedded with three layers of non-biodegradable mat and two layers of biodegradable mat. Typical details of the system are shown in Figure 5.
